Watershed Condition Summary for [Mill Creek](#)

Date: 8 September 2006

Mill Creek Subwatershed

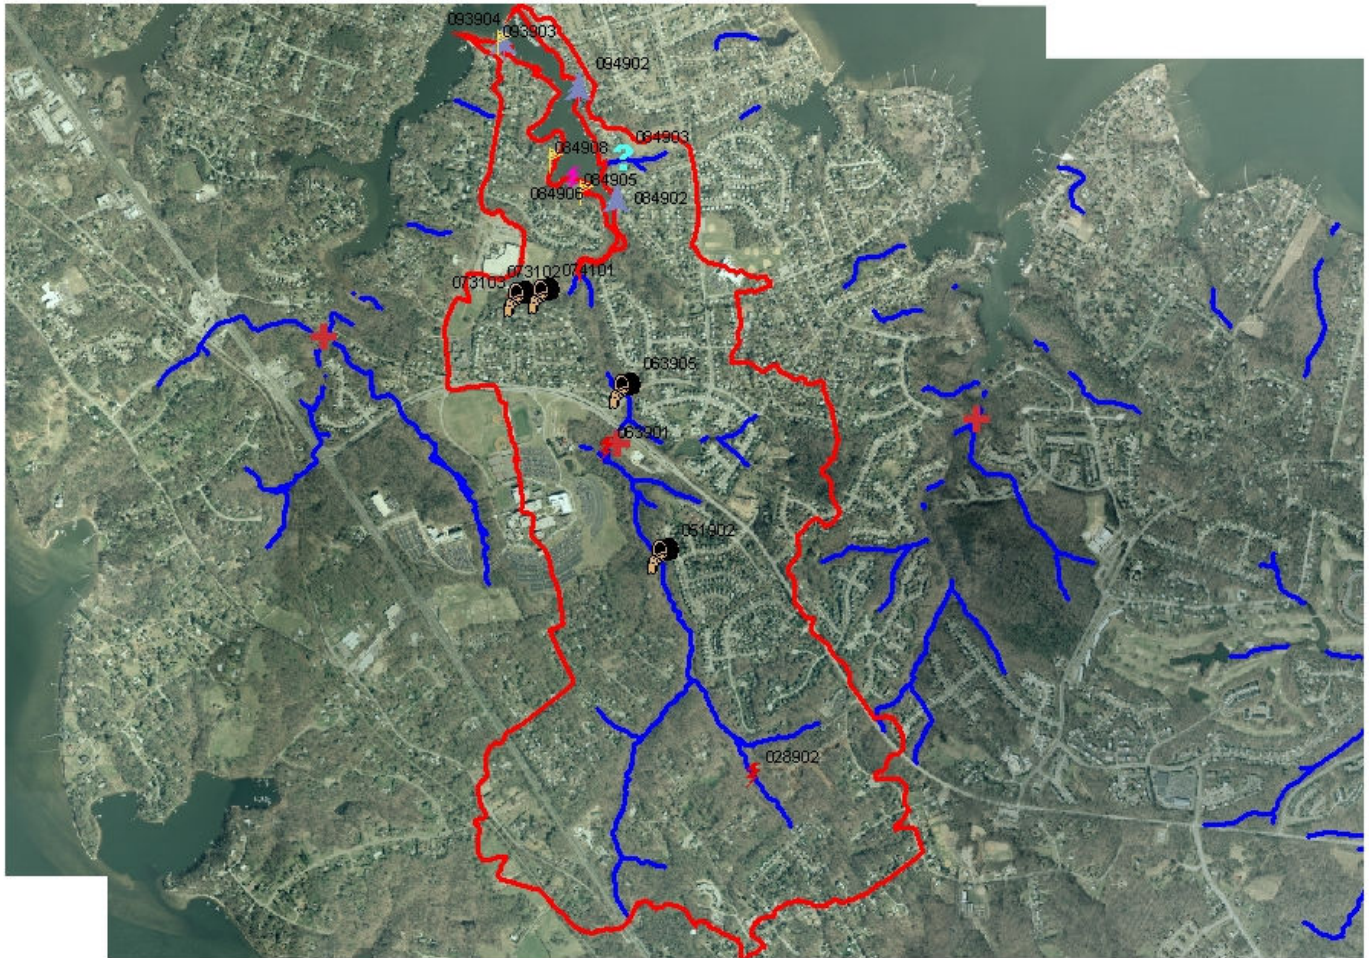
Figure 24. Overview of Mill Creek Subwatershed (#105) with Potential Restoration Project Locations

Specific restoration projects identified for the Mill Creek subwatershed are listed in Table 32. The locations of these projects are illustrated in Figure 24.
