Watershed Condition Summary for [Dividing Creek](#)

Date: 8 September 2006

Dividing Creek Subwatershed

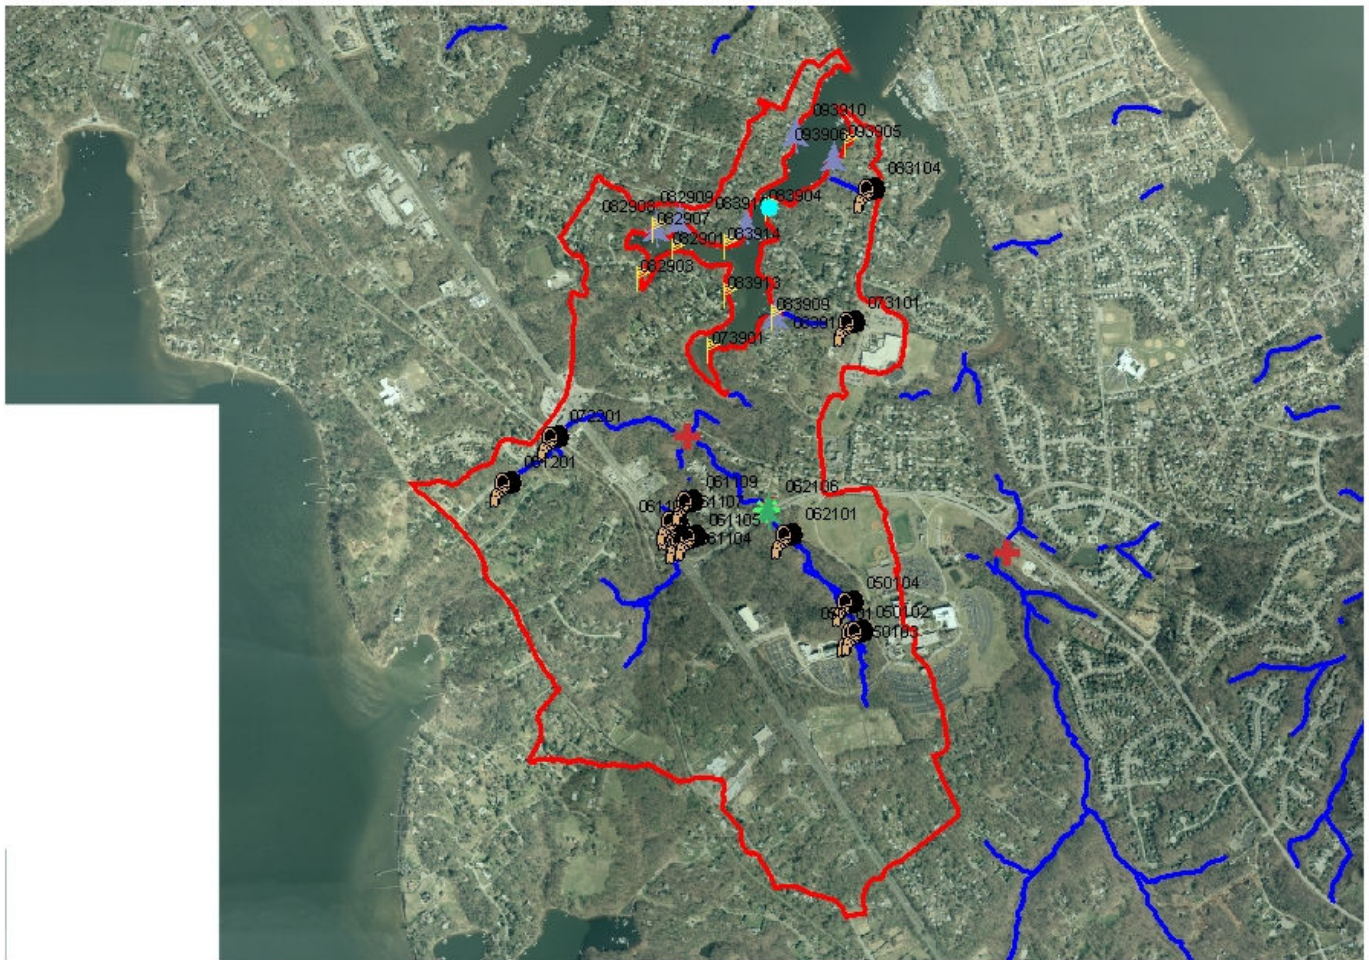
Figure 23. Overview of Dividing Creek Subwatershed (#103) with Potential Restoration Project Locations

The SCA identified 17 environmental concerns of moderate severity or greater, the majority of which are pipe outfalls. Two erosion sites, one fish blockage, and one inadequate buffer make up the remainder of the project list. The Tidal Shoreline Survey identified 15 potential environmental concerns, primarily associated with altered shorelines and inadequate riparian buffer areas.

Table 31 lists the specific projects identified during the SCA and the Shoreline Survey. Project locations are illustrated in Figure 23.
